Manhole Inspection Summary

Manhole # S19K1_013MH

Insp Date: **5/2/08 9:45 AM**

Location Address: **2626 janice av**

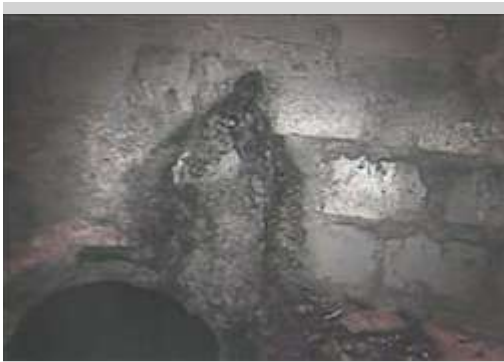
Defect 3

Infiltration: ☐ None ☐ Joint ☐ Cracks ☐ Mortar ☐ Roots ☒ **Wall**

infiltration@ barrel wall

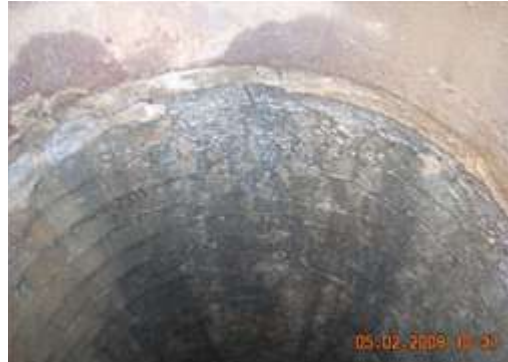
Defect 2

Infiltration: ☐ None ☒ **Joint** ☐ Cracks ☐ Mortar ☐ Roots ☐ Wall

infiltration @ chimney/frame joint

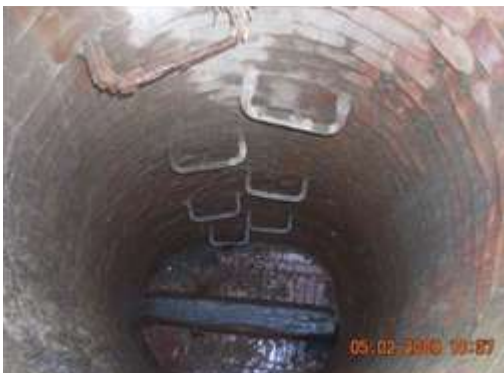
Defect 1

Steps Count: **7** Missing: **0** ☒ **Corroded**

corroded steps

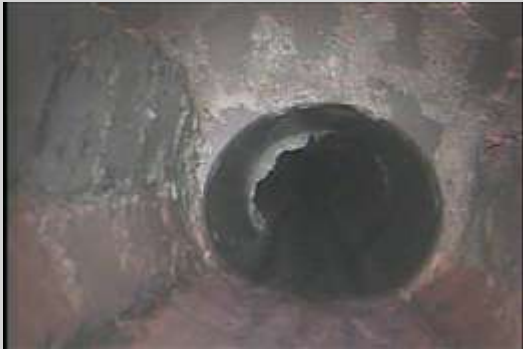
12 O'Clock Outflow

8 in. Circular Gravity Sewer
Pipe Out @ 12 O'Clock

Pipe Height: **8.4** (in.) Rod and Bar (Angled)
Pipe Material: **Clay** ☐ Pipe Lined
Invert Depth: **13.33** (ft.) Flow Characteristics: **Slow**

Deposits: ☐ None ☐ Mud ☐ Sludge ☐ Debris ☒ Grease

Silt Depth: **1** (in.) Deposits Extent: **Light**

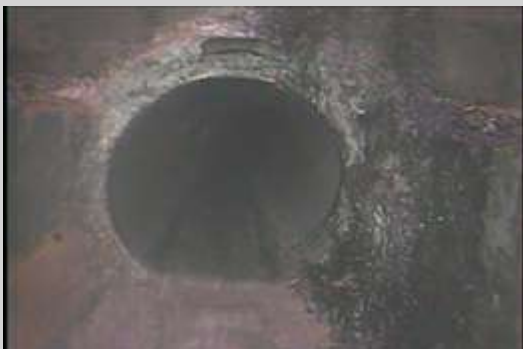
6 O'Clock Inflow

8 in. Circular Gravity Sewer
Pipe In @ 6 O'Clock

Pipe Height: **8.4** (in.) Rod and Bar (Angled)
Pipe Material: **Clay** ☐ Pipe Lined
Invert Depth: **12.88** (ft.) Flow Characteristics: **Slow**

Infiltration: **Evidence** Pipe Seal Cond: **Sound**
